Experience from Chemical Cleaning of a 23 Years Old Intermediate Pressure Superheater in Unit 5 at Asnaes Power Station (ASV5)

Svend-Erik Therkildsen

Chemical Engineer, B.Sc.C.E., Kyndby Power Station, Energi E2, Kyndbyvej 90, DK-3630 Jægerspris, Denmark.

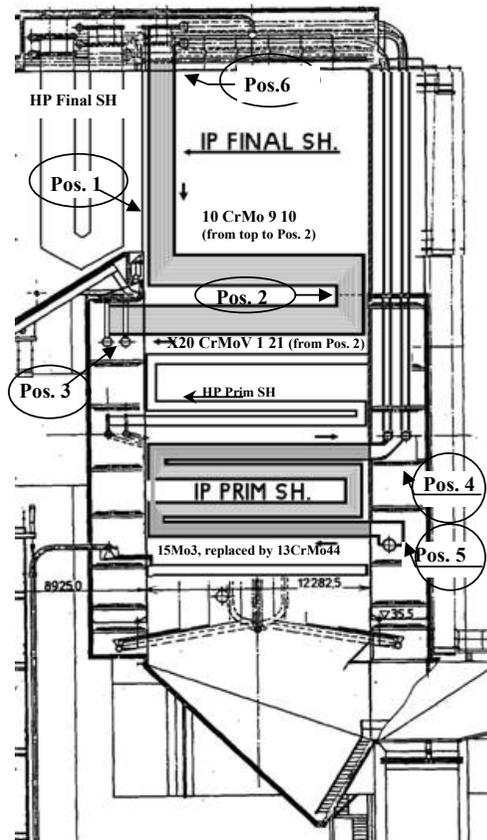
Fig. 3. ASV5. Enlarged sectional view of the second pass.

In connection with the preliminary investigations regarding the life extension, tube samples have been taken, i.a. from the IP-SH in 1998, 2001 and 2002. In 1998, 3 tube samples were taken from the IP Final SH around the welds between 10CrMo910 and X20CrMoV121 (Fig. 3, Pos. 2). In 10CrMo910, 0.41 mm oxide was found, and in X20CrMoV121 0.16 mm. In 2002, up to 0.450 mm was measured in 10CrMo910 in tube sections with the same position, and 0.143 mm in X20CrMoV121.

In 2001, at 1.5 m above the bottom of horizontal pass (Fig. 3, Pos. 1), oxide films of up to 0.760 mm were measured in 10CrMo910. This position in the boiler is probably the most critical with regard to remaining useful life and flaking (highest temperature flux).

2.5. Chemical cleaning sequences During pressure testing, 3 leaks were observed in the IP Final SH outlet header made of low alloyed 10CrMo910 (Fig. 3, Pos. 3). This outside corrosion was caused by a too high temperature in the hottest pipes combined with entering sulphur from the flue gas.

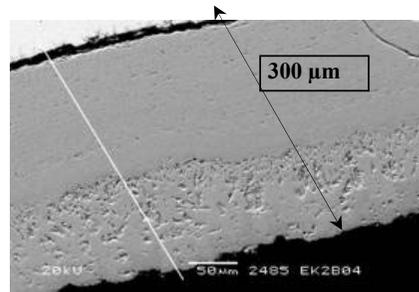
Fig. 7. EK2B04, 10CrMo910 from the IP Final SH. The white line indicates the section for the elementary analysis in Fig. 8.

It can be seen from the elementary analysis that there is also an innermost film containing chromium in 10CrMo910, but this film obviously does not contain that much chromium.

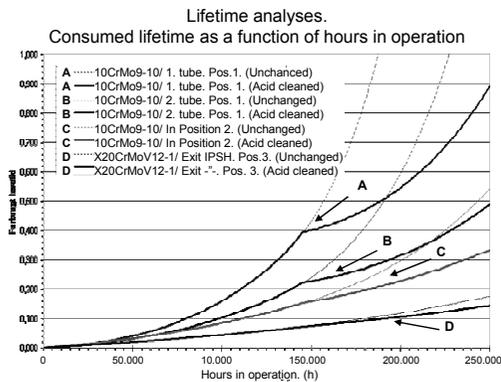
2.3. Calculations of life A number of calculations of life have also been made, which indicate that some of the tubes in the IP Final SH would have used up their lives in a few years. This is due to the thick, insulating oxide deposit, which causes the

metal temperature to rise. A rising steel temperature increases the growth rate of the oxide film, whereby consumed life grows exponentially (see Fig. 9). Consequently, the tubes of the IP Final SH had to be replaced or chemically cleaned. According to the calculations, the desired extension of life can be achieved through chemical cleaning, and as chemical cleaning is considerably less expensive than a replacement, chemical cleaning was the chosen solution. Some of the prerequisites for the graph below is an expected performance of the chemical cleaning after 145,000 hours (in the year 2003) and removal of 60% of the oxide film calculated for the tube subjected to the heaviest thermal loaded position: 1.5 m above the bottom of horizontal pass, where the oxide film measured was 0.76 mm.

Fig. 9. Calculation scenarios with minimum creep rupture strength data. Positions 1-3 can be found in Fig. 3. For Pos. 1 (curves A and B), this corresponds to 1.5 m above the bottom of horizontal pass, while Pos. 2 is the 10Cr steel just before the transition to X20. Pos. 3 is the IP Final SH (X20) outlet just before the headers.

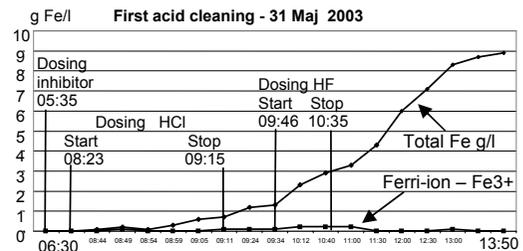
Fig. 10. Sequence and concentration of Fe²⁺ and Fe³⁺ during the first chemical cleaning.

The temperature in the IP-SH circuit is raised to 65 °C, and to begin with Rodine 213 is fed for dispersal in the system. 3 h later, hydrochloric acid + inhibitor are first fed and then hydrofluoric acid + inhibitor. HCl and HF are fed over approx. 2 h. The concentration in the IP-SH is now: 5% HCl, 1% HF and 0.15% inhibitor.

After 3½ h of acid treatment, the system is emptied of the acid, which is displaced by nitrogen. Then the IP-SH is flushed with water (deionised water) twice. The first time, the filling and emptying of the whole system is effected in one operation, while the second flushing takes place in 4 stages. At first, the two halves of the IP Prim SH are flushed separately at a flow > 200 kg/s, and then the two halves of the IP Final SH are flushed at a flow > 400 kg/s at the inlet.

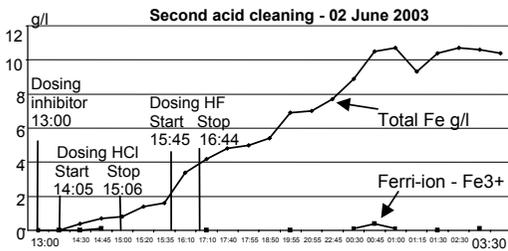
Fig. 11. Sequence and concentration of Fe²⁺ and Fe³⁺ during the second chemical cleaning.

The second chemical cleaning sequence also starts with heating of water to 65 °C and filling of the IP-SH. Rodine, HCl and HF are fed in the same order as during the first chemical cleaning sequence. This time, the concentration is 5% HCl, 2% HF and 0.15% inhibitor. The acid circulates in the IP-SH circuit for 11 hours before it is drawn off. The acid is displaced by a nitrogen cover in order to reduce corrosive attacks.

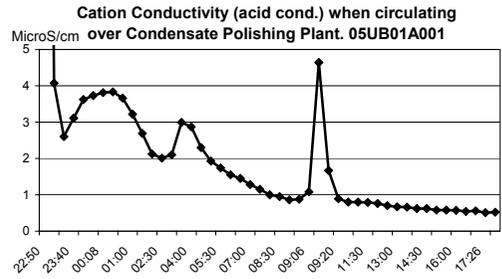
Fig. 12. Acid Conductivity in the IP-SH during recirculation via a condensate polishing plant. The peak at the nine o'clock position is due to shut-down(s) and pressure testing and inspection.

When the final flushing has been completed, there is water in the system, the pH is 9.2-9.6, the conductivity is 20–40 μS/cm, and there is no excess hydrogen peroxide. Recirculation is established in the IP-SH via a condensate polishing plant for approx. 19 h whereupon the water in the circuit is so clean that the process is stopped and temporary measures are dismantled.

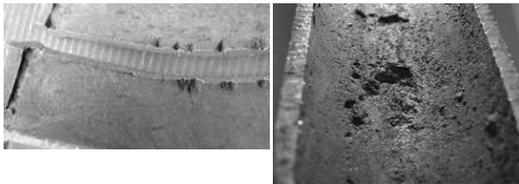
Leaks. Some leaks are discovered in inlet headers as well as in outlet headers of the IP Prim SH. Tube sections are cut out, and leaks are sealed with rubber and clips, or hoses are mounted where tubes have been cut out. Tube samples taken show severe pitting, crack formation and a good deal of sludge at the bottom of the tubes. It was decided to try to patch up all holes and pressure test the IP-SH again. If the attempts at sealing the IP-SH were successful, the cleaning programme would be continued.

The conclusion from the examination of the condition of the superheater is that there is very widespread pitting in the IP Prim SH. The findings are not systematic and unambiguous, but statistically there is more widespread corrosion in horizontal tubes adjoining an upward tube. In such places, water may also collect if the horizontal tubes have the wrong slope. Tube samples taken have pitting in depths up to 3 mm, which means that only 0.5 mm remains of the thickness. The worst corrosion and the most damage have been detected in the lower-most tubes.

Fig. 13. Pitting in 15Mo3 steel in the IP Prim SH.

In response to the condition of the tubes in the IP Prim SH, it was decided to replace all of the superheater hoses from inlet header to outlet header, a total of 208 bulkheads of 8 tubes of approx. 57 m each. The new IP Prim SH was made of 13CrMo44 with the dimensions 44 x 3.6 mm. The tubes were chemically cleaned in lengths of 13-14 m by means of inhibited hydrofluoric acid in the workshop. A total of 340 tonnes of tubing for the IP Prim SH has been chemically cleaned and mounted in the boiler during the summer of 2004.
