Experience from Chemical Cleaning of a 23 Years Old Intermediate Pressure Superheater in Unit 5 at Asnaes Power Station (ASV5)

Svend-Erik Therkildsen

Chemical Engineer, B.Sc.C.E., Kyndby Power Station, Energi E2, Kyndbyvej 90, DK-3630 Jægerspris, Denmark.

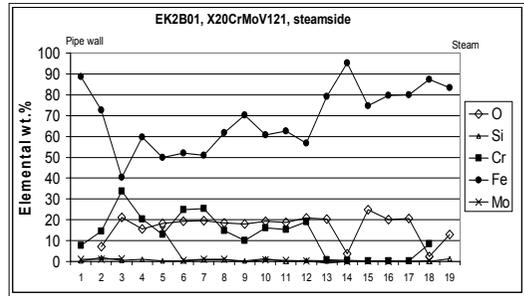
Fig. 6. Elementary analysis of EK2B01, X20.

Fig. 4 Flakes of oxide. Fig. 5 shows the section for the elementary analysis in Fig. 6. The samples are numbered from the steel surface (Left at the curves).

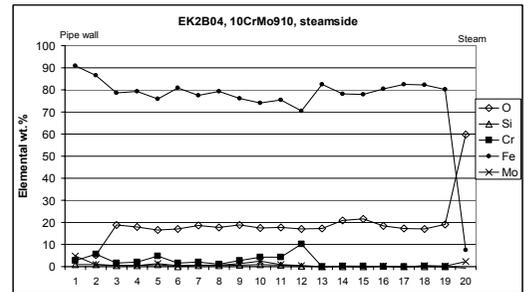
Fig. 8. Elementary analysis of EK2B04, 10Cr.

It can be seen from the elementary analysis that there is also an innermost film containing chromium in 10CrMo910, but this film obviously does not contain that much chromium.
